SELECTIVE LEACHING (“Dealloying”, “Parting”)

Corrosion in which one constituent of an alloy is preferentially removed, leaving behind an altered (weakened) residual structure.

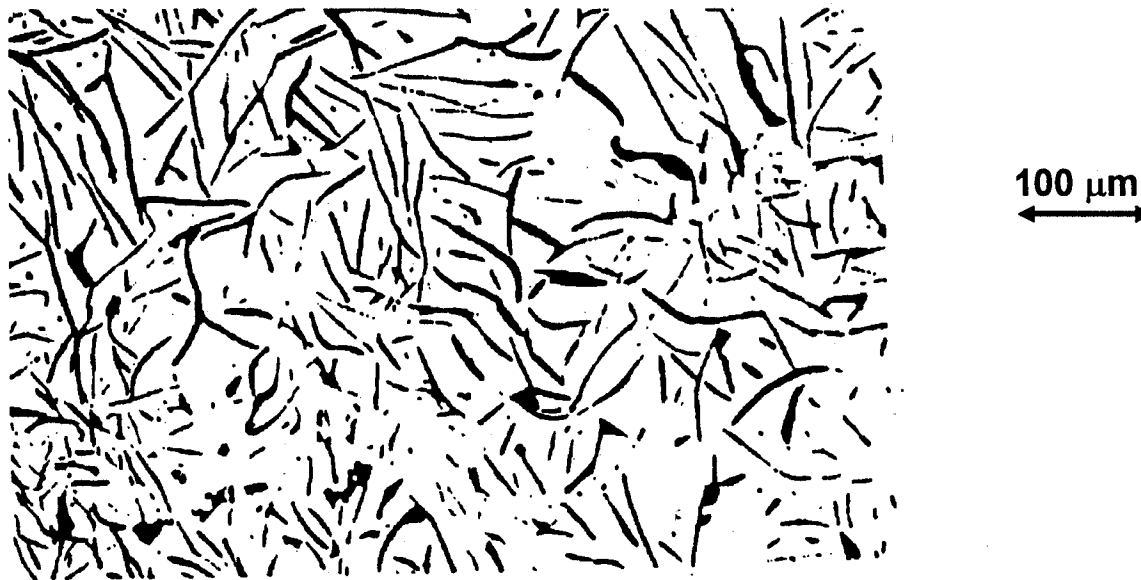
Microstructure of gray cast iron.

Hard, brittle, easily cast; carbon present as microscopic flakes of matrix graphite within microstructure.

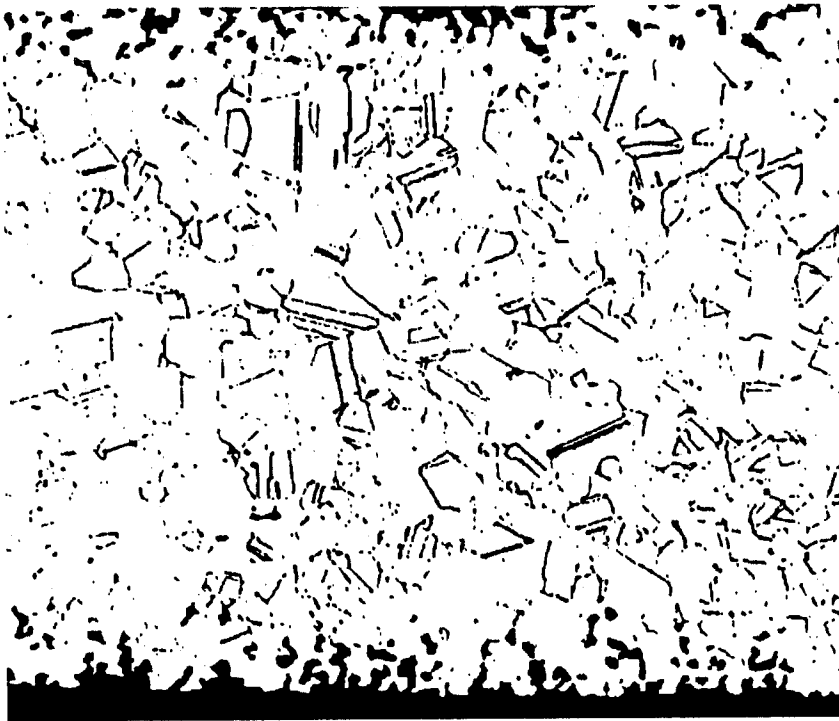
- (c) microstructure of type 304L SS exposed to $\text{LiF-BeF}_2\text{-ZrF}_4\text{-ThF}_4\text{-UF}_4$ (70-23-5-1-1 mole % respectively) for 5700 hours at 688°C.
- (d) microstructure of type 304L SS exposed to $\text{LiF-BeF}_2\text{-ZrF}_4\text{-ThF}_4\text{-UF}_4$ (70-23-5-1-1 mole % respectively) for 5724 hours at 685°C.

dealloying of Cr from Ni-base alloys and stainless steels can occur in the surface layers exposed to molten fluorides; the vacancies in the metal lattice then coalesce to form subsurface voids which agglomerate and grow with increasing time and temperature.
