# Lecture 4 – Case Studies (cont'd)

Dr. V.G. Snell

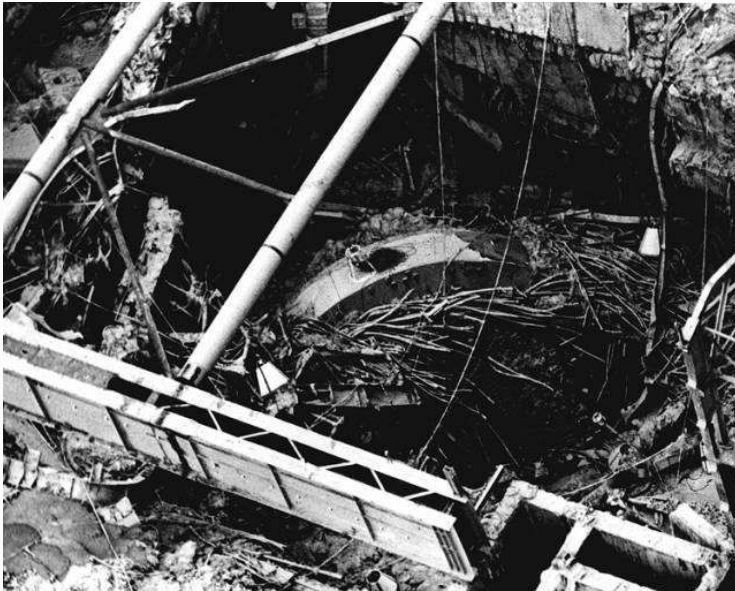
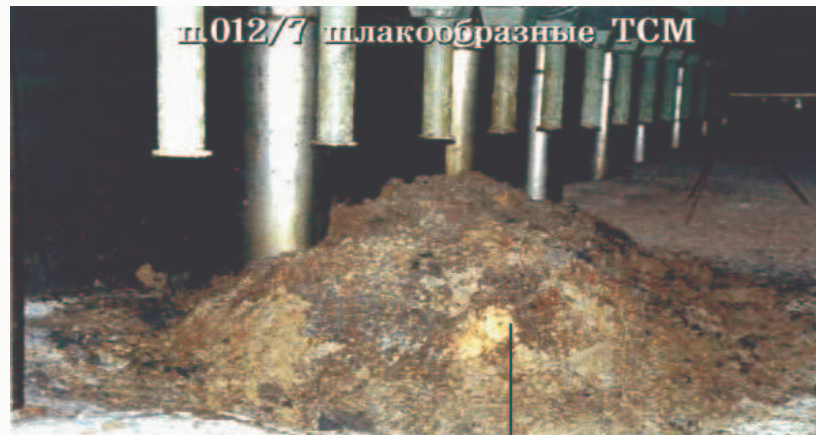
# Chernobyl core damage

- Massive core destruction / dispersal – subcritical
- Graphite fire for several days
- Core melted and 'lava' flowed into rooms below reactor; core area empty

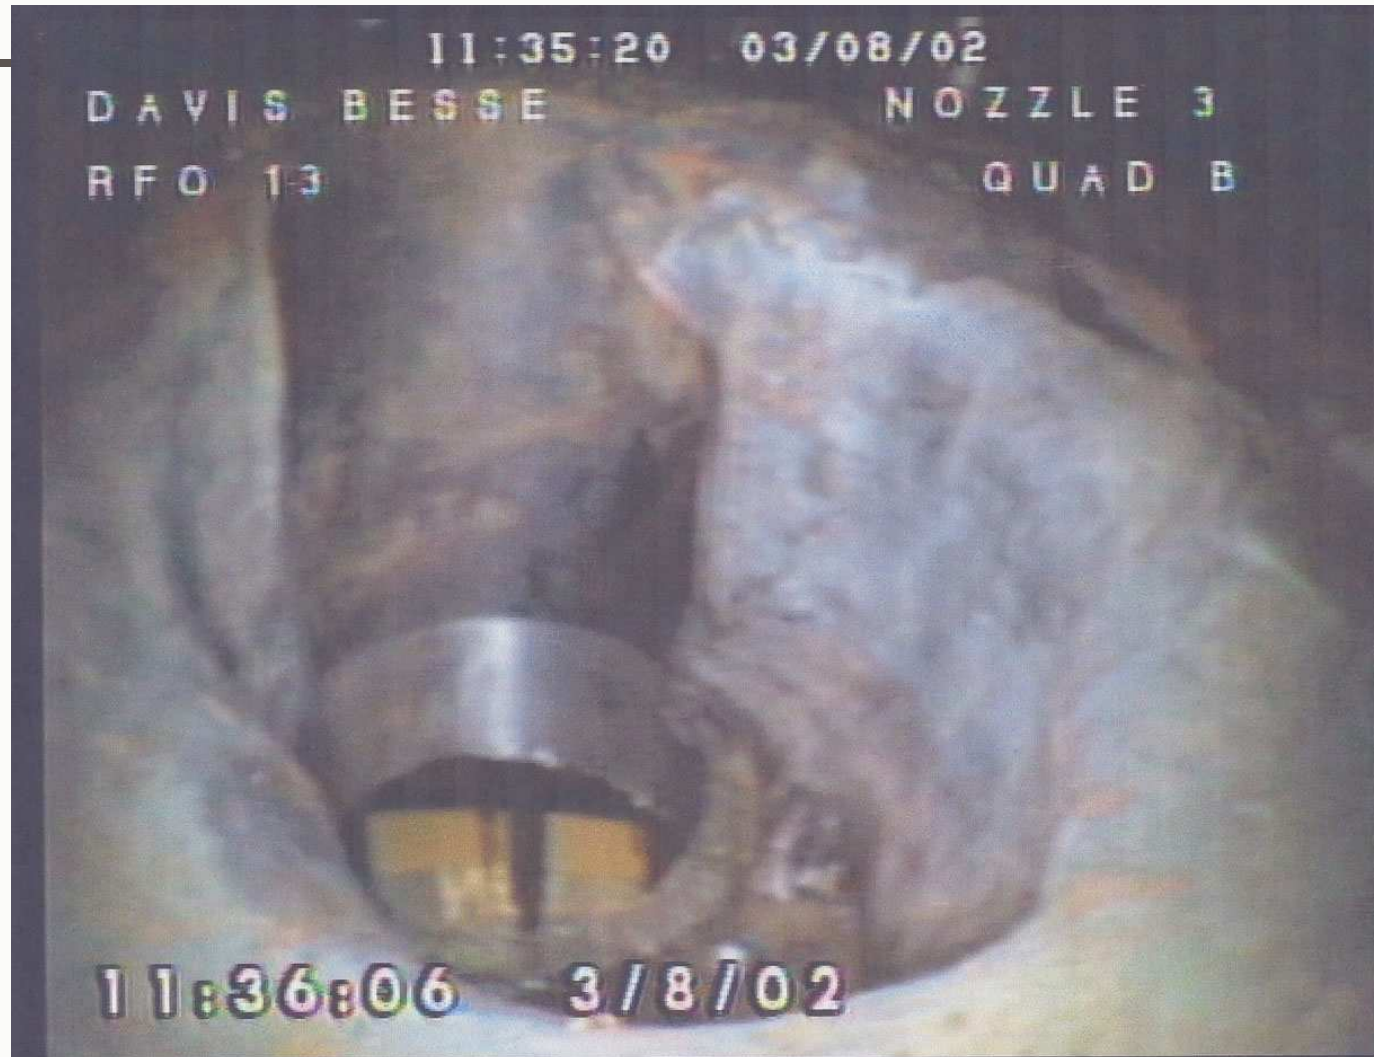
# DB - A Hole in the Head

Stainless steel liner bulged, but did not fail
