NEUTRON RADIOSCOPY AT THE SLOWPOKE-2 FACILITY AT RMC FOR THE INSPECTION OF CF-18 FLIGHT CONTROL SURFACES

T. R. Chalovich

Department of Chemistry and Chemical Engineering, Royal Military College of Canada,
Kingston, Ontario, Canada K7K 7B4
chalovich-t@rmc.ca

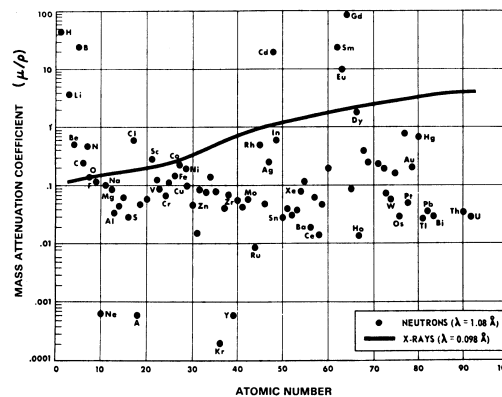
Figure 1 - Mass Attenuation Coefficients as a Function of Atomic Number¹

Neutron radiography is a Non-destructive Testing (NDT) technique which is complementary to X and Gamma radiography. Neutron radiography utilises neutrons, which interact with nuclei of atoms rather than with the orbital electrons as does X or Gamma radiation. A comparison of the mass attenuation coefficient for most of the elements for thermal neutrons and X-radiation (Figure 1) shows that each nuclide has its own characteristic neutron cross section which shows no pattern compared to the increasingly uniform attenuation with mass number for X and Gamma radiation. In fact, there is a slight reverse or complementary trend towards light elements for neutrons. The major advantage of neutron radiography is its ability to see light elements such as contained in corrosion and water. The energy spectrum, composition and quantity of neutrons in the beam at the image plane will determine image quality and exposure time.

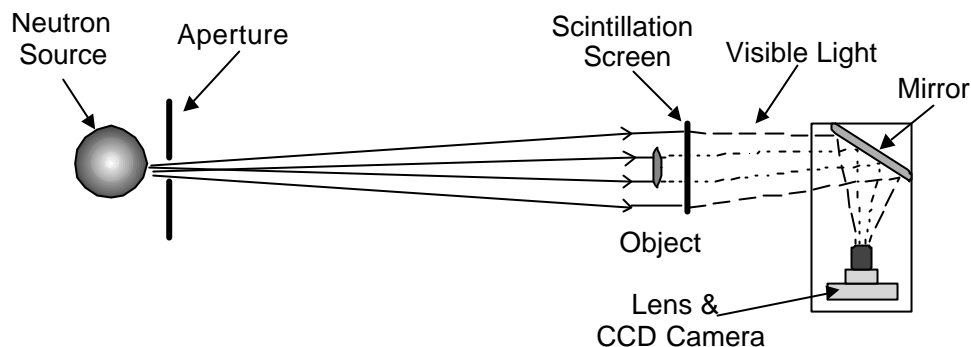
Neutron radiography does not utilise film but rather a Vidicon video camera with screen intensifiers or a Charged Coupled Device (CCD) camera with a scintillation screen to record the image. The image is stored in a digital format on a computer for viewing and digital enhancement purposes. The major disadvantage of neutron radiography is poor image resolution while the advantages include good image contrast, reduced exposure time, very good image linearity and the ability to manipulate image data. A typical configuration for neutron radiography is shown in Figure 2.

Figure 2 - Neutron Radioscopy Configuration

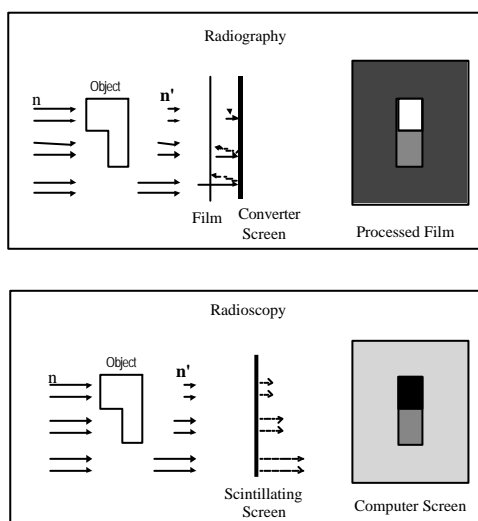
In radioscopy, neutrons interact (by either absorption or scatter) with an object, reducing the amount of neutrons that hit the scintillating screen. Therefore, the screen is not exposed in this area, but the remaining area of the scintillating screen will be luminous. The radiographer will view the area associated with the object as a darker shade of grey compared to the surrounding area. Essentially, a positive image, rather than a negative one, is directly obtained. Figure 3 is a drawing illustrating the results of radiography (using film) and radioscopy (using a scintillating screen).

Figure 3 – Radiography and Radioscopy Image Formation

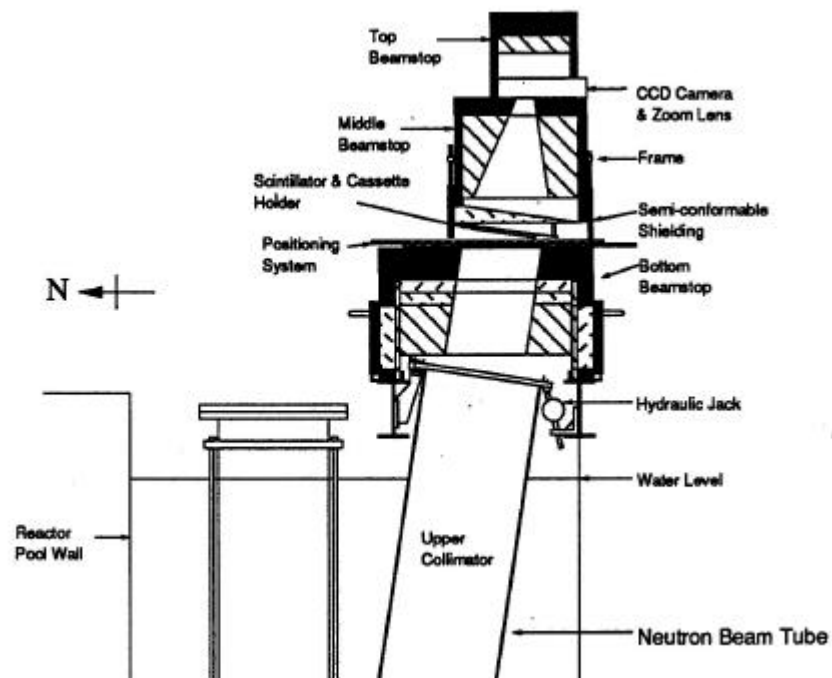
Two different nuclear reactors were used as a neutron source in order to determine the effects on the image of different neutron fluxes. The first neutron source used was the 20 kW_t research reactor in the SLOWPOKE-2 Facility at RMC. For neutron radiography/radioscopy, the reactor, which normally operates at half power (10 kW_t), produces a nominal neutron flux of 5.0×10^5 n/cm² s outside the reactor core and produces 2.0×10^4 n/cm² s at the image plane.⁴ The Neutron Beam Tube (NBT) is circular in cross section, tilted 8.5° from vertical and has a measured L/D of approximately 100.⁵ At the inlet of the NBT, the neutron beam passes vertically into a series of beam stops: through the bottom one (on top of which the object to be radiographed is positioned) and into the middle and top beam stop in which the scintillation screen and CCD camera are located. This arrangement is termed the Neutron Radioscopy System (NRS), Figure 4.

Figure 4 - NRS at RMC

The camera system consisted of a 431.8 mm (17 in.) x 431.8 mm (17 in) aluminium backed $^6\text{LiF:ZnS:Cu}$ scintillating screen, an Apogee AP7 CCD camera with a SITE502 CCD sensor, a front surface mirror with adjusting mechanism, a Vivitar AF-SC 28-70 mm, F3.5 zoom lens, an Apogee video capture board and a 200 MHz computer running Windows 98. The SITE502 CCD is a back lit, full frame CCD chip with an array size of 512 x 512 and a pixel size of $24\mu\text{m}$. The CCD camera, cooling unit, mirror and mirror adjuster are housed in a self-contained unit and is thermoelectrically cooled to a -30°C working temperature. For the experiment at Penn State, the same geometrical arrangement of the scintillation screen and CCD camera were temporally configured by designing an aluminium rectangular and trapezoidal enclosure that was dimensionally identical to the middle beam stop at RMC. Image acquisition was accomplished with "Image Pro Plus" and image analysis was completed with "IP Lab Spectrum –Scientific Imaging Software for Macintosh". All image analysis was done on an Apple Macintosh Computer, Model 8500, as recommended by the software vendor.

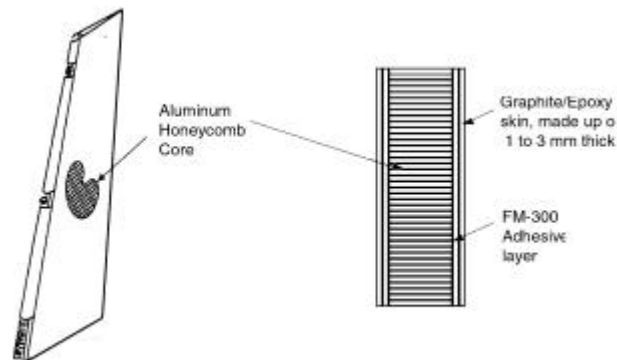
The covering on the rudder is carbon graphite (as indicated in Figure 5) and has an aluminium six sided honeycomb material used as the core of the component. The flight control surfaces have structural pieces that allow for hinge connection and strengthening of the trailing

edge which also completely seal the honeycomb (made from 5052 or 5056 aluminium alloy) inside the component.

Figure 5 - Construction of a CF-18 Rudder

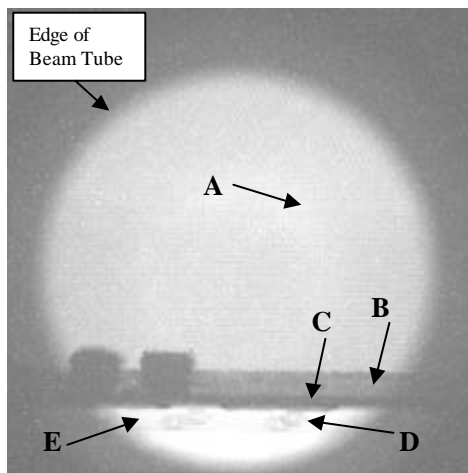
To understand the results of the neutron radioscopy performed on the CF-18 rudder, a basic knowledge of the internal structure is required. A neutron radioscopy image of a serviceable section of a rudder with its components labelled is shown in Figure 6. Table 1 lists the components corresponding to the capital letters in Figure 6.

Figure 6 – Exposure 2 of Rudder from Penn State

Since the neutron beam at Penn State did not completely cover the entire area of the scintillation screen, all RMC images were cropped so that the images could be compared. Only the data inside the circle were used in the histograms as the data associated with the dark area outside the circle were excluded from the histograms. All images are presented in a format similar to Figure 6 and contain similar internal components as indicated in Table 1.

Table 1 – Internal Components of CF-18 Rudder

Letter	Component
A	Aluminium Honeycomb pattern From FM300 adhesive
B	Porous Adhesive – Connects honeycomb to main spar
C	Main Spar – Aluminium material
D	10/32 Steel Anchor Nuts (four in total)
E	0.050 inch Aluminium Sheet – Fairing support

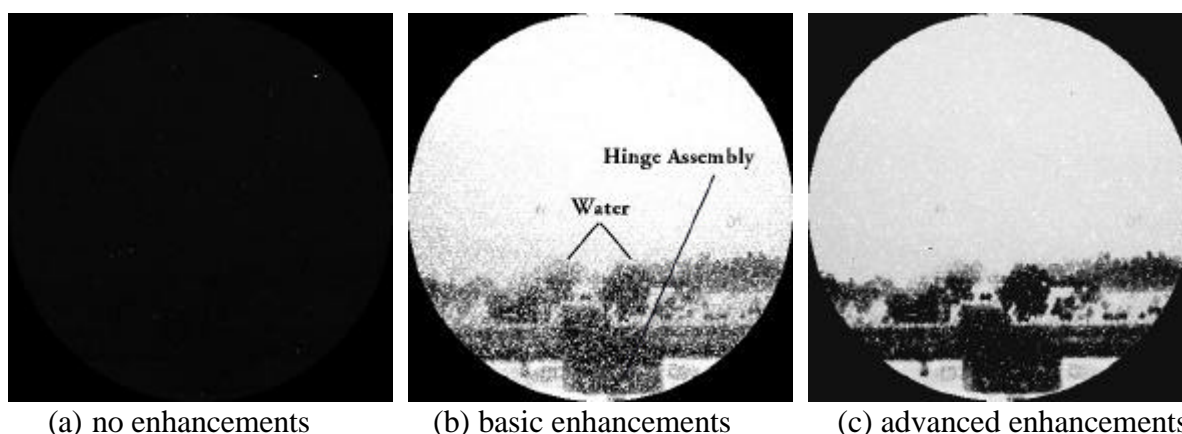
Figure 7 shows a series of images taken at RMC of Exposure 5. The original image (a) is without any data manipulation and the second image (b) had the contrast and brightness manipulated to make the original image visible. The last image (c) has had a 2 x 2 Erosion filter applied to the original image and then the brightness and contrast were manipulated.

Figure 7- Sequence of Exposure 5 images taken at RMC

Although not visible in Figure 7a, there are some white spots indicating gamma contamination or system noise. Figure 7b has very little definition, as some of the individual components shown in Figure 6 are not clearly distinguishable but water is indicated, as is the hinge assembly. Water ingress and its location in this area was previously known from neutron radiography. In Figure 7b and c, water ingress is visible and the pattern of water is identical to known images of this area. Figure 7c also indicates clearer details such as the main spar, porous adhesive and the anchor nuts.

The intensity values of the graph in Figure 8 are in the low thousands and therefore the original image is black as previously seen in Figure 7a. The intensity value does not have a large range, from 1536 to approximately 3500 values, producing an image with a small dynamic range, which reduces image contrast between components as shown in Figure 7c.

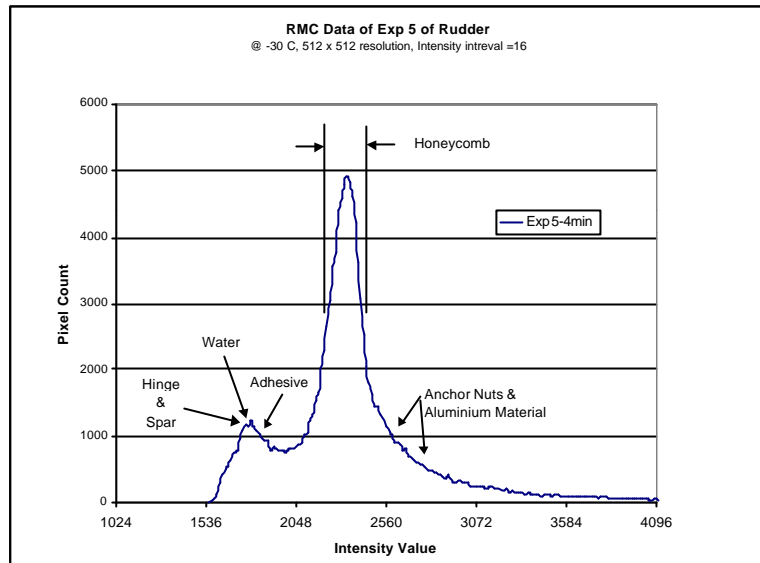
The histogram associated with the original image in Figure 7a of exposure 5 taken at RMC is shown in Figure 8. Thresholding was applied to the image to identify the features on the curve and are indicated on the histogram.

Figure 8 - Histogram of Exposure 5 from RMC (10 kW_t)

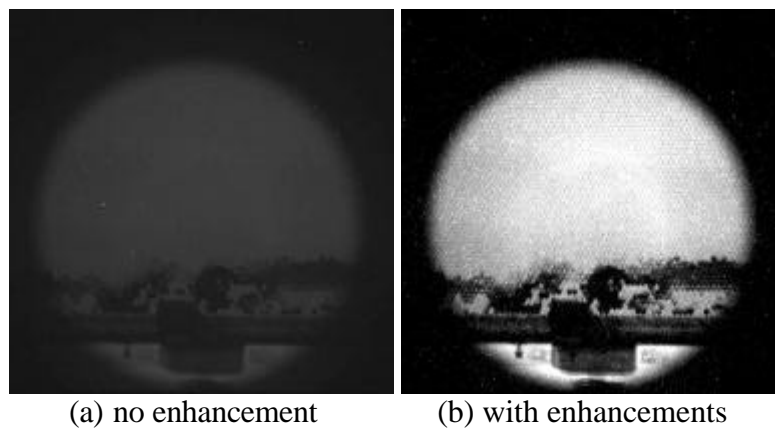
An image of Exposure 5 was taken at Penn State with the reactor at 100 kW_t, Figure 9a and b. At this power setting, the flux at the image plane was two magnitudes greater than available at the RMC NRS. Due to the higher flux values, the only enhancement required was a small change to the contrast and brightness to produce the image in Figure 9b.

Figure 9 - Sequence of Exposure 5 images taken at Penn State, 100 kW_t

Unlike the previous unaltered images, the rudder components are visible and, with only a small amount of contrast and brightness adjustment, a good image of Exposure 5 can be seen in Figure 9, b. All internal components show good definition and dynamic intensity range.

This histogram has a very large intensity scale ranging from approximately 3000 to 12000. Since the histogram spans past the intensity value of 10,000, the image should be visible as can be seen in Figure 9a. The large dynamic range of this histogram should translate to significant differences in intensity values for given internal components of the rudder, which can be seen in Figure 9b.

The image produced at a 100 kW_t power setting in Figure 9 has the best definition and largest range of intensities compared to the other images taken at RMC and Penn State (at lower power settings). Both images from RMC (10 kW_t) and Penn State (at 100 kW_t) show the internal components of the rudder and the water ingress in Figure 11. Due to the clarity of the images produced from the Penn State reactor at 100 kW_t, these images can be used as a comparison standard.

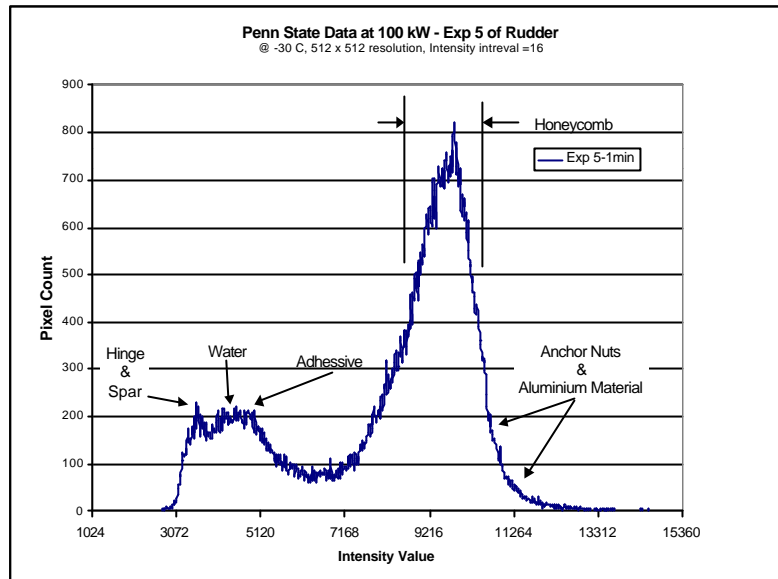
The applicable histogram for Figure 9a with labels indicating the major components of the rudder is presented in Figure 10.

Figure 10 -Histogram of Exposure 5 from Penn State at 100 kW_t

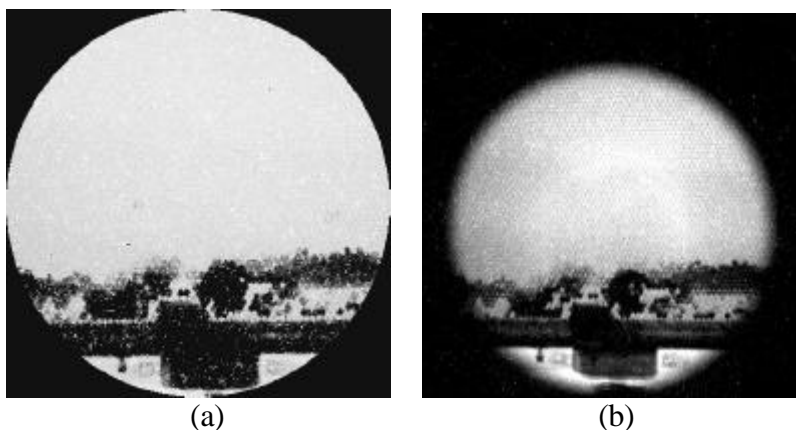
Figure 11 - Exposure 5 from (a) RMC at 10 kW_t, and (b) Penn State at 100 kW_t

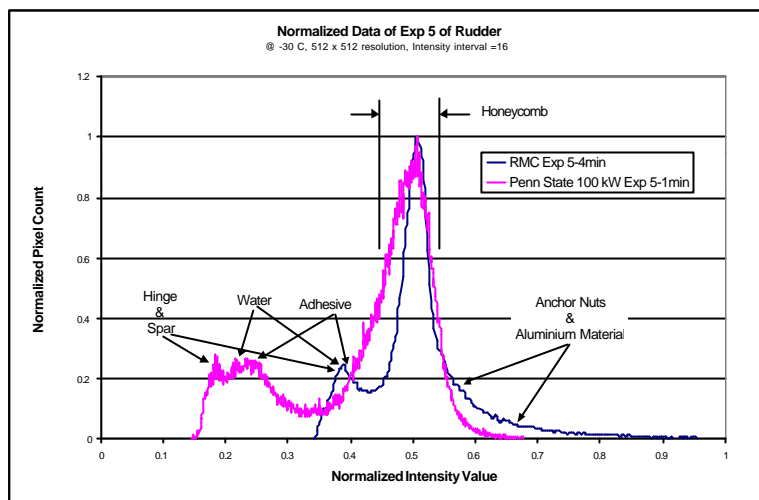
Plotting normalised histograms of Exposure 5 for RMC at 10 kW_t with an exposure time of 4 minutes and Exposure 5 from Penn State at 100 kW_t with an exposure time of 1 minute

produced results shown in Figure 12. Both sets of data were normalised to the centroid of the honeycomb peak.

Figure 12 - Normalised Graph at Two Different Power Settings

Normalising the data allowed a direct comparison between the two graphs and compensated for the large variation of values of the pixel count and intensities. The goal in normalising the data was to confirm that both images produced similar shapes and features that related to the internal components of the rudder. Although the histogram graphs are not identical, the shapes are similar and features on the graph do relate to specific items in the images. The difference between the two graphs shows that the histogram from the image taken at Penn State uses a good percentage of the intensity scale. The curve of the histogram from the image taken at RMC is compressed on the left side of the peak and elongated on the right side of the peak relative to the other histogram. Overall, the image taken at RMC contains all the required data to produce an image that is capable of indicating the honeycomb pattern, main spar, porous adhesive, anchor nuts, aluminium structure and water ingress.
